Dam Engineering Project

Glenclyff Hydro Dam Repair Benton, NH

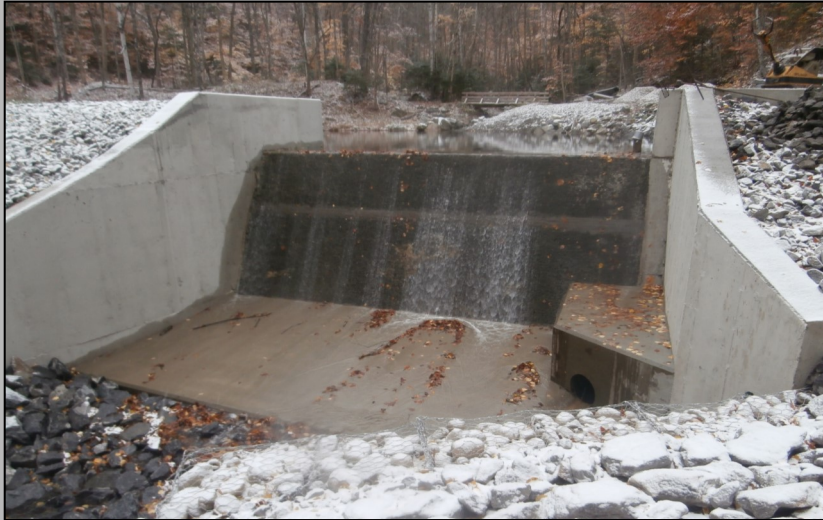
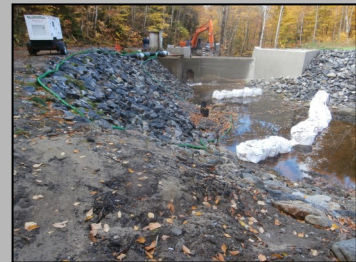
The Glenclyff Hydro Dam (Dam #023003) is located in the Town of Benton, NH and serves the Glenclyff Home as a source of water for a hydroelectric facility, fire protection system, and laundry facility. The 125-foot long earthen embankment dam has a top bank width of approximately 20 feet and an impoundment with a normal capacity of approximately 2 acre-feet. The existing dam consisted of a stone masonry spillway encased in cast-in-place concrete with concrete masonry block downstream training walls, a right earth embankment dam with a field stone masonry core wall and badly deteriorated upstream concrete training wall, and a left abutment consisting of a cast-in-place concrete intake structure.

QCC designed repairs to the spillway that improved the hydraulic capacity of the spillway, slip-lined and redirected the existing low level outlet, and replaced the training walls. The left abutment was reconstructed downstream of the intake structure, and the existing penstock was encased in concrete to protect it. The undermined and badly deteriorated spillway apron was replaced with a new apron including toe drains. The repairs also included protection of the right upstream core wall and stabilization of sloughing embankment slopes within the impoundment and downstream of the dam.
