Bridge Replacement Project

North Main Street over Miller Brook

NHDOT Br. 172/088

Antrim, NH

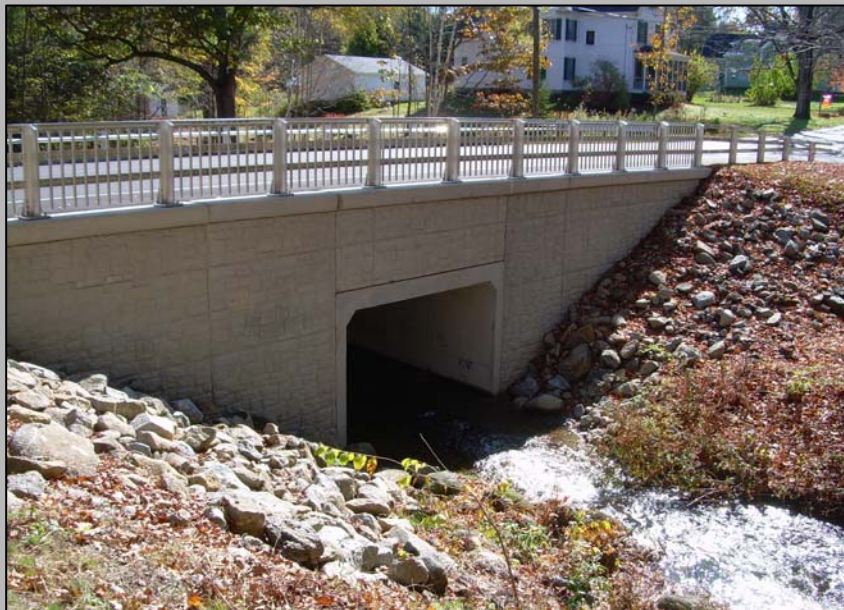
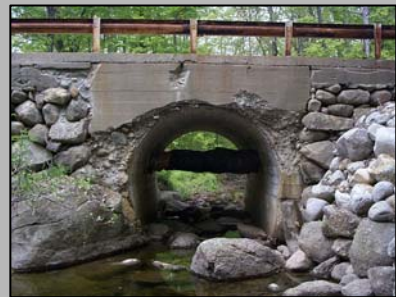
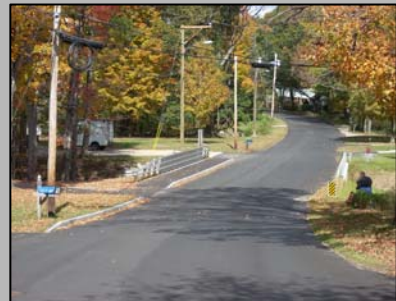
During the period of May 12 to May 23, 2006, heavy rains in the Antrim area caused unusually high flow through the North Main Street Arch Culvert. The structure and stone masonry wingwalls were subjected to a high level of water and extreme flow velocity.

QCC performed a damage assessment and confirmed that the foundations had lost material beneath the arch due to stream scour. Soil loss through the stone masonry abutments occurred from receding water following the submerged condition. A large sinkhole formed in the roadway fill behind the south abutment and southeast masonry wingwall. A sewer and water line were on the bridge and at risk during flood events.

QCC performed a hydraulic study and found that this waterway has the potential to serve as a flood relief to the downtown area. QCC evaluated mitigation alternatives and recommended replacement with a new concrete box structure with natural streambed materials placed in the invert. The water line was relocated to be protected in the roadway fill above the structure and the sewer line was installed under the streambed.
