# Flood Mitigation / Bridge Replacement Project

Old Marlborough Road over Charcoal Brook

NHDOT Br. 089/099

Dublin, NH

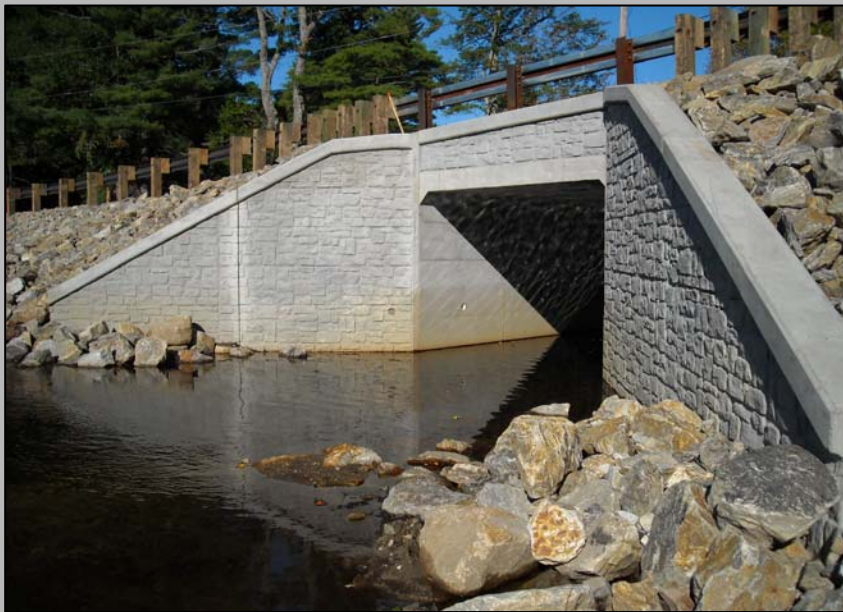
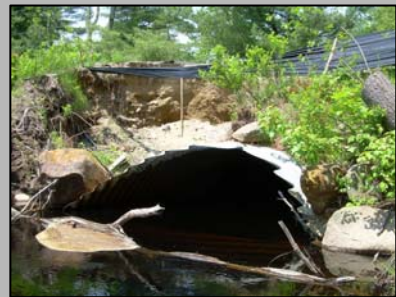
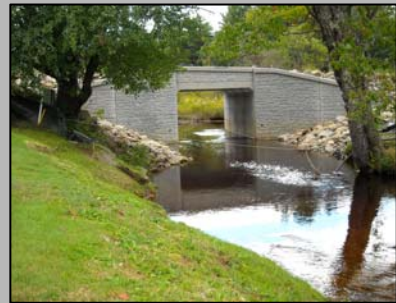
Old Marlborough Road Bridge over Charcoal Brook was severely damaged by flooding in April 2007. The 8-foot high by 12-foot span corrugated metal pipe arch culvert was undermined, resulting in the collapse of the culvert and roadway failure.

The Town of Dublin contracted with Quantum Construction Consultants, LLC to design a replacement bridge structure and 500 feet of roadway reconstruction under a fast track schedule. The replacement bridge structure is an 11-foot high by 12-foot wide box culvert with natural streambed material placed in the bottom.
